**Flood Control Project Maintenance  
Levee Inspections**

## Maintenance Issue Types Only, Levee Inspection Report By Mile - Spring 2016

### Reclamation District No. 1001 Nicolaus

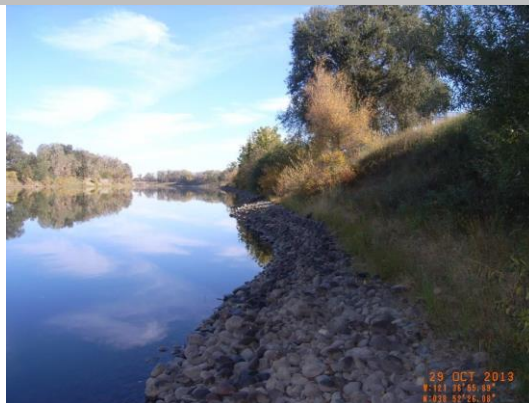
Photo 1 of 1 : SP\_2016\_RD1001\_38\_2\_20160307\_00002.jpg

LM Start	5.80	Rating **	M	Issue No.	2
LM End	5.93	Issue Type +	Ma	Location *	WS
Category	Supplemental			GPS Latitude/Longitude	
				Start	End
Item	2015 USACE Erosion Survey, DRAFT			38.874113 °	38.872373 °
				-121.615380 °	-121.616504 °
DWR ID	DWR_RD1001_04_s_2016_2				
Comment Code					
Inspector Comment					
2011 - Erosion pockets from tree popouts. Sections of the lower bank have slumped off. 2013 - Scallops from tree popouts no longer visible on site. Minor new erosion at the middle of the bank. 2015: Fresh erosion from human use. [2015 Site ID: FHR_6-6_L]

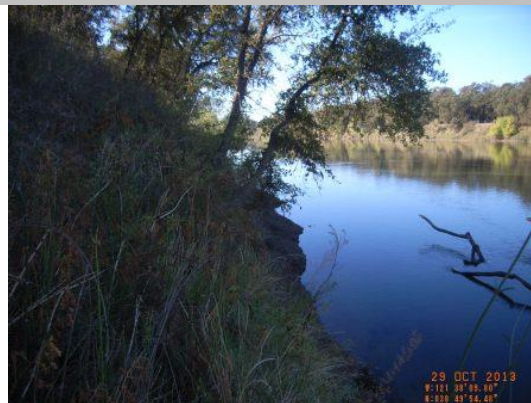
Photo 1 of 1 : SP\_2016\_RD1001\_38\_7\_20160307\_00007.jpg

LM Start	8.57	Rating **	M	Issue No.	7
LM End	8.97	Issue Type +	Ma	Location *	WS
Category	Supplemental			GPS Latitude/Longitude	
				Start	End
Item	2015 USACE Erosion Survey, DRAFT			38.836966 °	38.831498 °
				-121.634128 °	-121.636371 °
DWR ID	DWR_RD1001_04_s_2016_7				
Comment Code					
Inspector Comment					
2006 - Sandy, silty bank with intermittent pockets of erosion. Rotational failure and tree pop outs are most of the problem. Some upper slope fluvial erosion. 2010 - Site extended upstream. The lower Feather may benefit from a regional repair. 2011 - Site combined with 3.6. Minimal new erosion. 2013 - New erosion observed at bank toe. Trees on site now have exposed roots. 2015: No observed changes. [2015 Site ID: FHR 3-8 L]

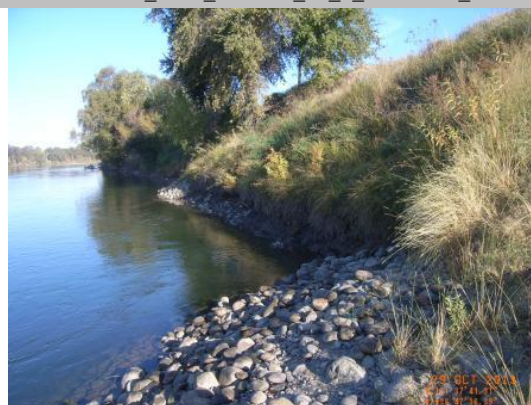
Photo 1 of 1 : SP\_2016\_RD1001\_38\_1\_20160307\_00001.jpg

LM Start	11.59	Rating **	M	Issue No.	1
LM End	11.75	Issue Type +	Ma	Location *	WS
Category	Supplemental			GPS Latitude/Longitude	
				Start	End
Item	2015 USACE Erosion Survey, DRAFT			38.795455 °	38.793394 °
				-121.629903 °	-121.628156 °
DWR ID	DWR_RD1001_04_s_2016_1				
Comment Code					
Inspector Comment					
1997- Deposits over top of cobble on the upper slope. 2000 - Old cobble site in poor shape; some toe retreat, but little change; steep bank. 2010 - Site extended upstream due to new toe erosion. 2012 - Minor new erosion at toe, new slumping, animals holes and cracks observed. 2015: No observed changes. [2015 Site ID: FHR_0-6_L]
